Land West of Brampton

Site Survey

Site 6: Brampton

Site 7: Brampton

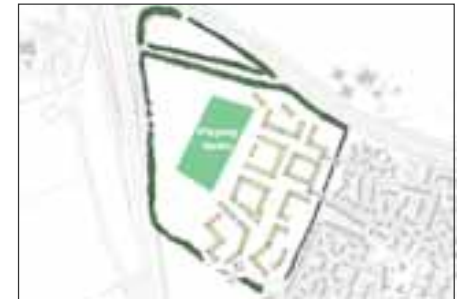
Site Analysis

This site is available but has limited suitability for residential development.

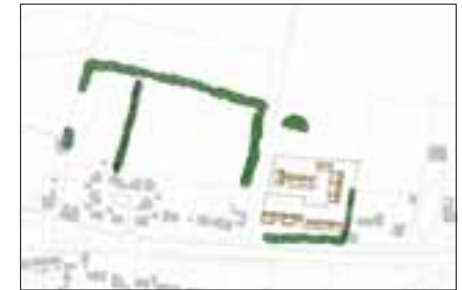
Site Analysis

This site may not be available but some of the site is suitable for residential development.

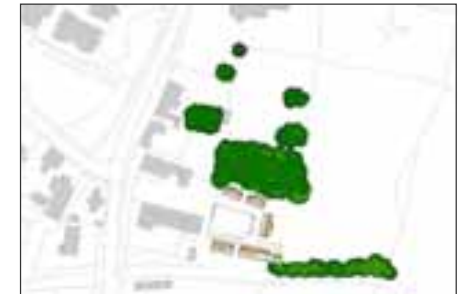
Site Analysis

This site may not be available and has limited suitability for residential development.

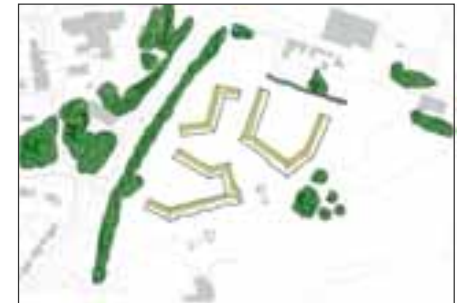
Site Analysis

This site is available but has limited suitability for residential development.

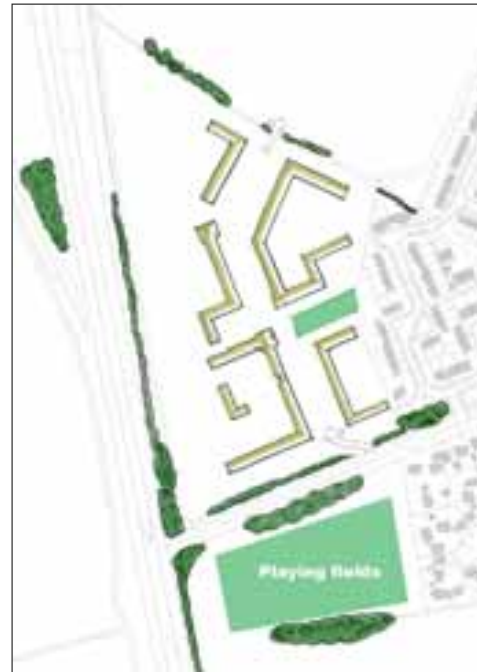
Site Analysis

This site is available but has limited suitability for residential development.
